M E M O R A N D U M

SUBJECT: Initial Assessment of 1409 Dundee Road, Elgin, Illinois

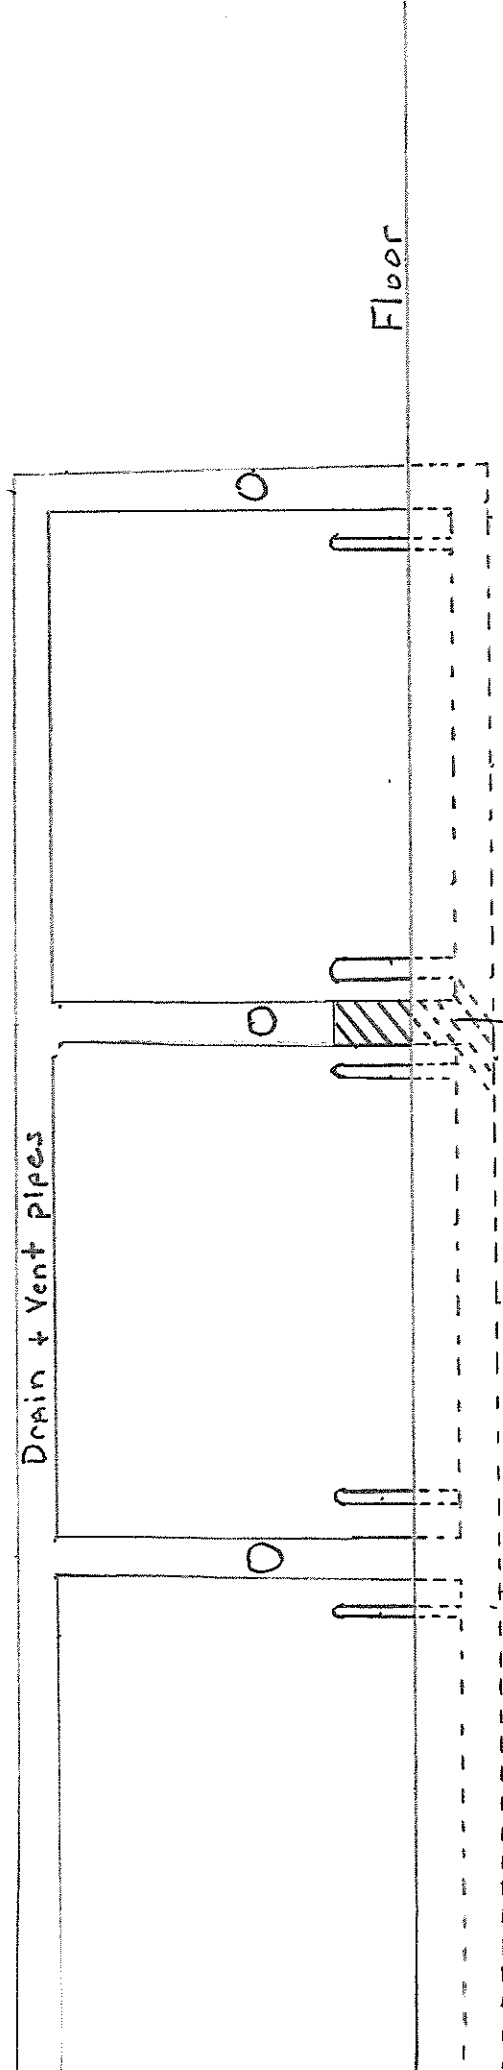
Diagram A

An internal survey of the building, with scintillators showed one small area on the south end of the building to have gamma levels of 300,000 cpm at the surface. Upon reviewing diagram A you will notice that my low energy probe indicated that the contamination followed a drain pipe for what used to be a bank of sinks. The radiation levels showed an inverted "T" pattern and Mr. Jadown confirmed that that is how the drain pipes were constructed. None of the other drains showed elevated levels. A survey of this drain area with an alpha probe showed no levels above background and a wipe test of the area showed no removable contamination. Ion chamber readings showed .1 mR/hr. As indicated earlier, there were no other areas of contamination in the floors, walls or drains of the building.

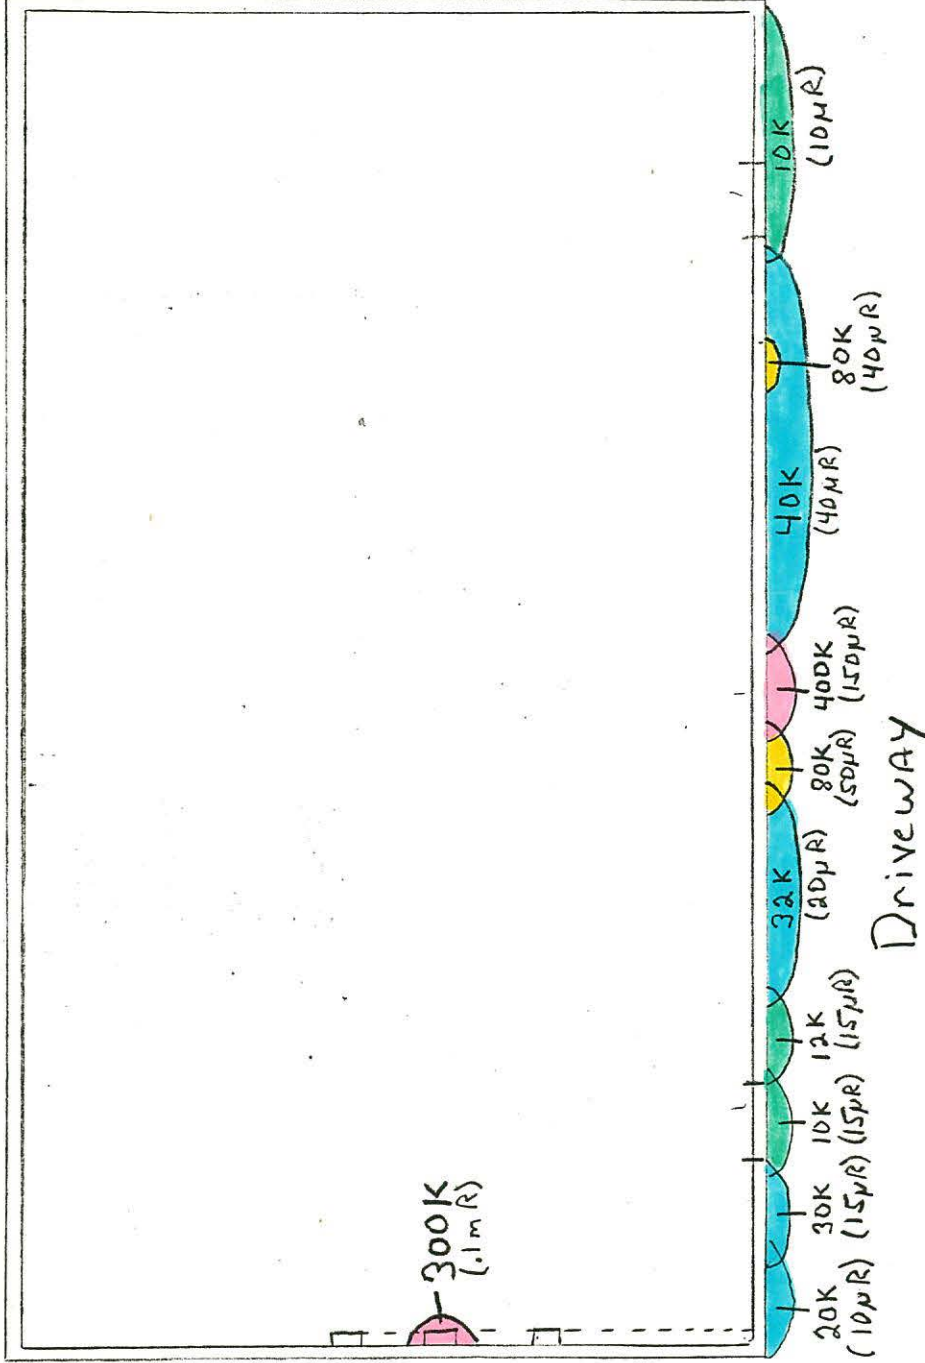
Diagram B

An external survey of the building and yard to the east showed a much more extensive spread of contamination. Referring to diagram B, you will find that the entire east side of the building showed elevated gamma levels with a maximum of 400,000 cpm at surface level. The yard showed eight areas of contamination with a maximum surface level of 200,000 cpm. Micro R levels are also recorded in diagram B and showed a maximum level of 150 micro R at 3 feet. The other areas of the property showed no levels above background. As of yet, the isotope(s) involved have not been determined. I will be running a spectral analysis of soil samples taken from the yard to identify those isotope(s) and their concentrations.

According to Mr. Jadown, the proposed construction of the parking lot would undoubtedly invade the areas of contamination. Building the parking lot would involve stripping the top soil off and creating a negative grade towards the center for a storm sewer. I stressed to Mr. Jadown that we needed to prevent any contamination from leaving the site, if disposal is not required. I stated to Mr. Jadown that my unofficial gut reaction was; that we would need to isolate these areas of contamination, dig them up and stockpile them in the existing parking lot and reduce the volume through sorting to limit the quantity used as backfill. When the trench for the storm sewer is dug, we could then use this material, along with the contaminated drain pipe, to fill in the lower areas of the trench. Because pea gravel is the normal backfill, this would allow a lower pressure pathway for radon and would insure no increased radon levels in the building.
